# Lincoln Highway Streetscape Plan

## Project Background

July 22, 2014

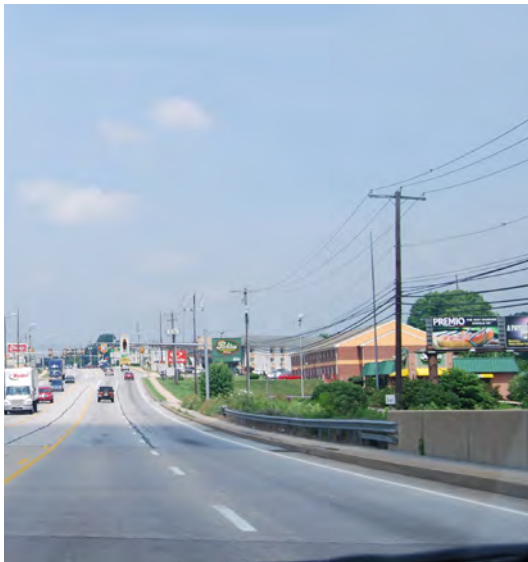
The bridge is located 700 feet east of the intersection with Harvest Road/ Mennonite School Road. While the existing structure width meets the minimum design criteria for traffic lane widths, curb offsets and sidewalk width, it is only 78 feet wide, narrower than most of the corridor. It includes four traffic lanes and a 12-foot center left turn lane and five-foot sidewalks on each side, though there is no barrier between the sidewalk and traffic lanes.

*Picture of bridge structure over Mill Creek*

- There could be potential for sidewalk expansion on the bridge over Mill Creek without widening the structure. This would require converting the center left turn lane into a narrower median and restriping the lanes. The resulting space could be transferred to the sidewalks, a far less costly option than structure widening.
- The lack of major cross streets intersecting with Lincoln Highway means that almost all of the access to businesses in the corridor must be directly from Lincoln Highway.

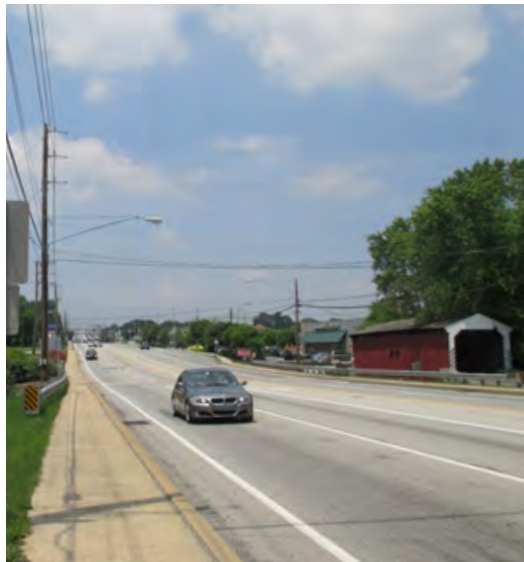
This existing bridge structure carries five lanes with sidewalks on both sides with a guide rail at the back of sidewalk. Additional sidewalk width or space for buffering the sidewalk from traffic would require structure widening; however, any widening of this bridge structure would negatively effect the adjacent covered bridge and meandering stream condition.

*Picture of bridge structure at Rockvale Outlet frontage*

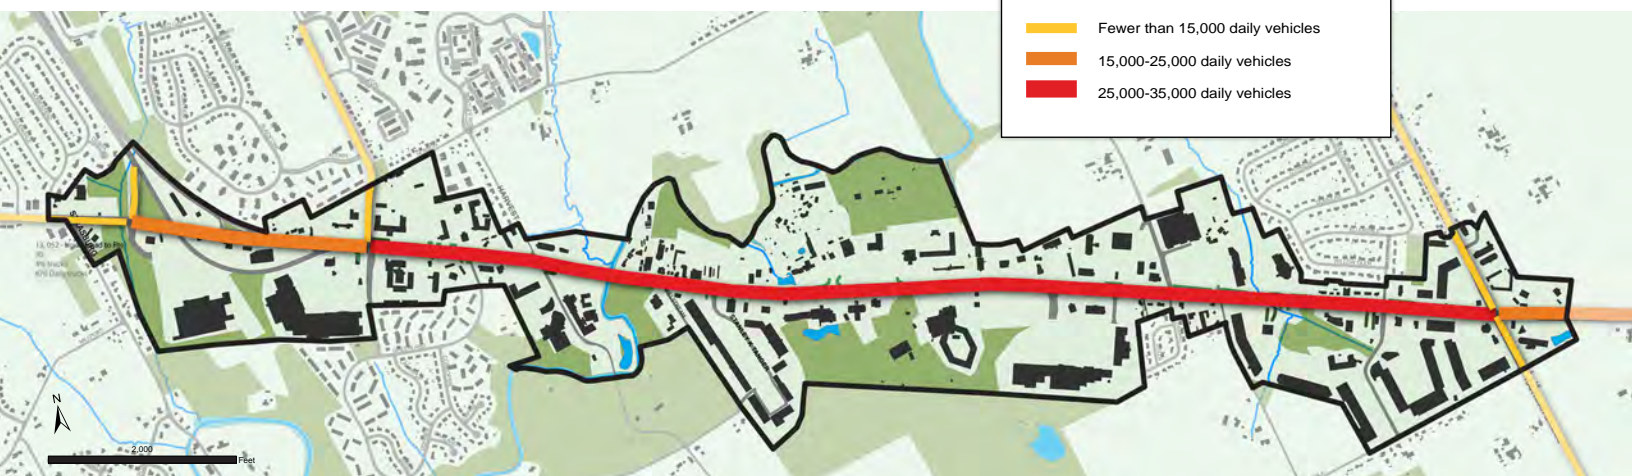
## traffic volume

Traffic volume along the corridor varies from an average of 22,000 vehicles per day west of the Bypass to an average of 30,000 vehicles per day between the Bypass and Route 896. The break at the

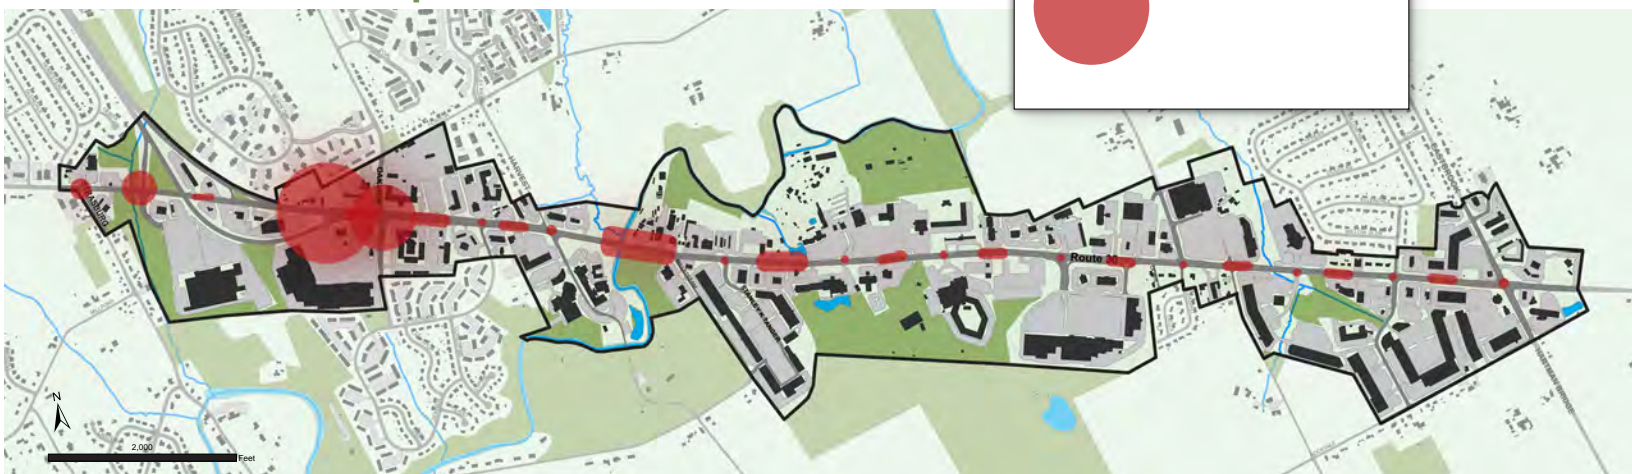
accidents map

The Study Area has a relatively high rate of accidents, with 343 “reportable” crashes along the corridor in the most recent five-year PennDOT study (2009-2013). PennDOT defines reportable crashes as those in which an injury or fatality occurs or where at least one of the vehicles is towed from the scene. The physical location of those 343 crashes is shown on the map below.

One-third of all the accidents over that time period happened in three locations in and around the Route 30 Bypass at the western edge of the Study Area.

- The concentration of accidents at a few key locations gives us the opportunity to make strategic safety improvements. The concentrations happen near the Bypass and on mid-block areas with access management issues.

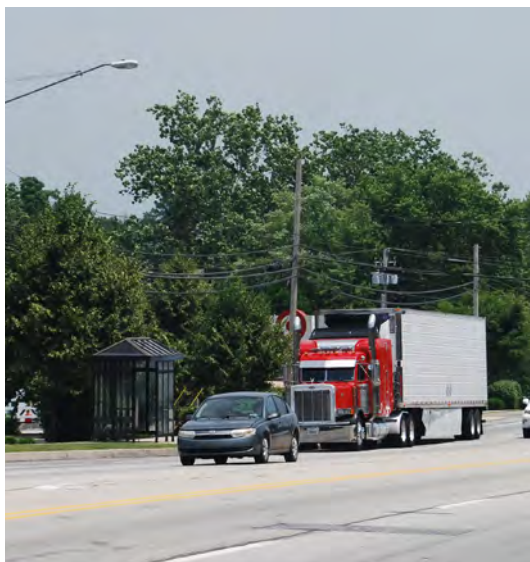
*Truck traffic passing by a Route 14 bus stop*

- Truck traffic will continue to be an issue for the corridor.
- While there are no easy solutions to adjusting the intense levels of truck traffic through the Study Area, widening center lanes (for trucks), narrowing outer lanes (for passenger vehicles), and providing signage to indicate the intended users of each lane could begin to address some concerns by pulling truck traffic to the centerline of the road.

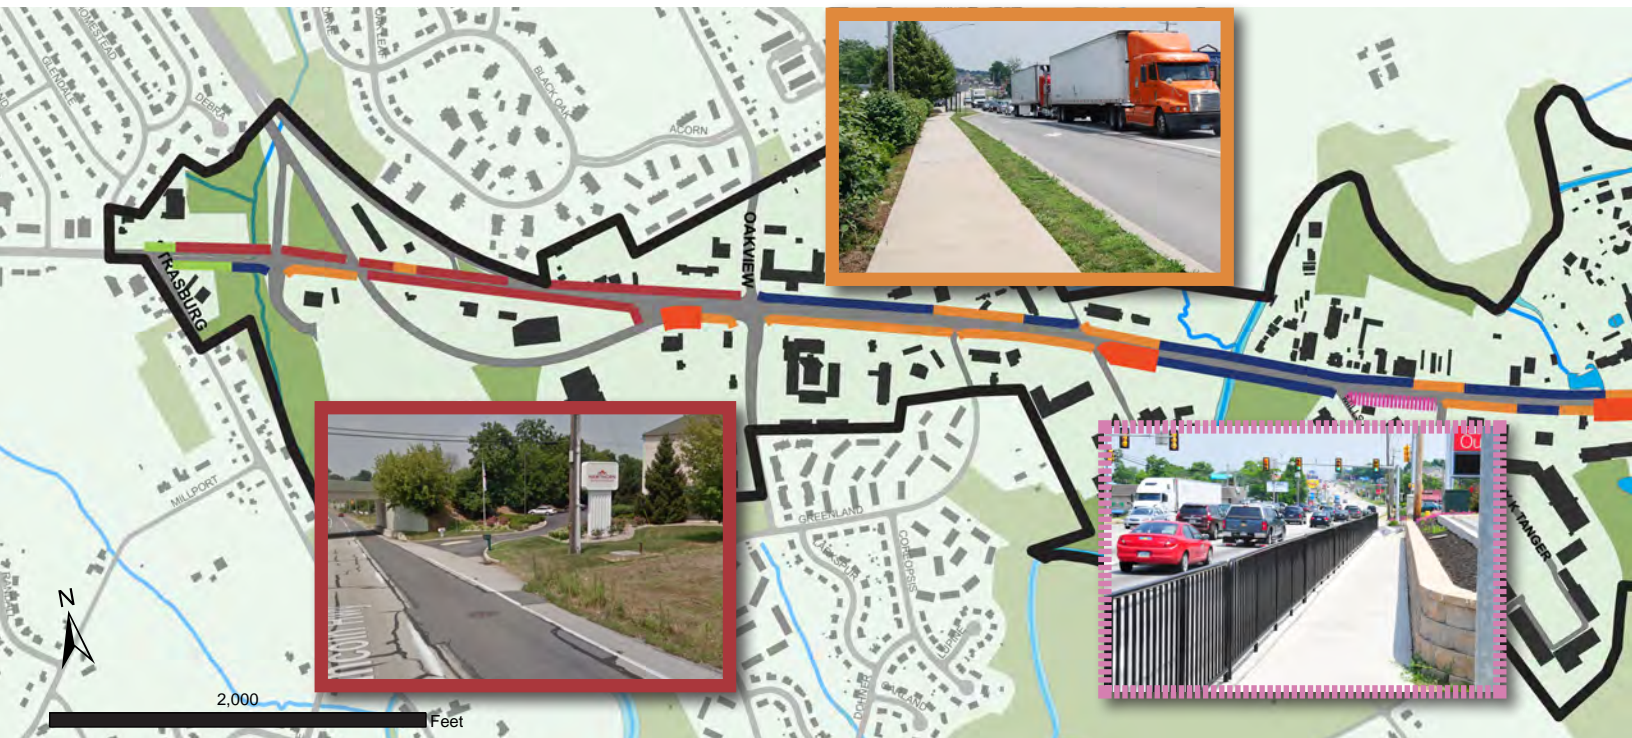
## Sidewalk conditions

An inventory of the sidewalks along Lincoln Highway reveals a surprising fact: 86 percent of the corridor has a sidewalk. As shown in the map below, the corridor frontage without sidewalks is almost entirely contained within the Route 30 Bypass ramps at the western edge of the Study Area.

An analysis of sidewalk conditions reveals that the pedestrian experience in the corridor is affected more by sidewalks that lack of protection from adjacent traffic than by a complete lack of sidewalks. The following is a brief description of five categories of sidewalk physical qualities and the percentage of each along the corridor.

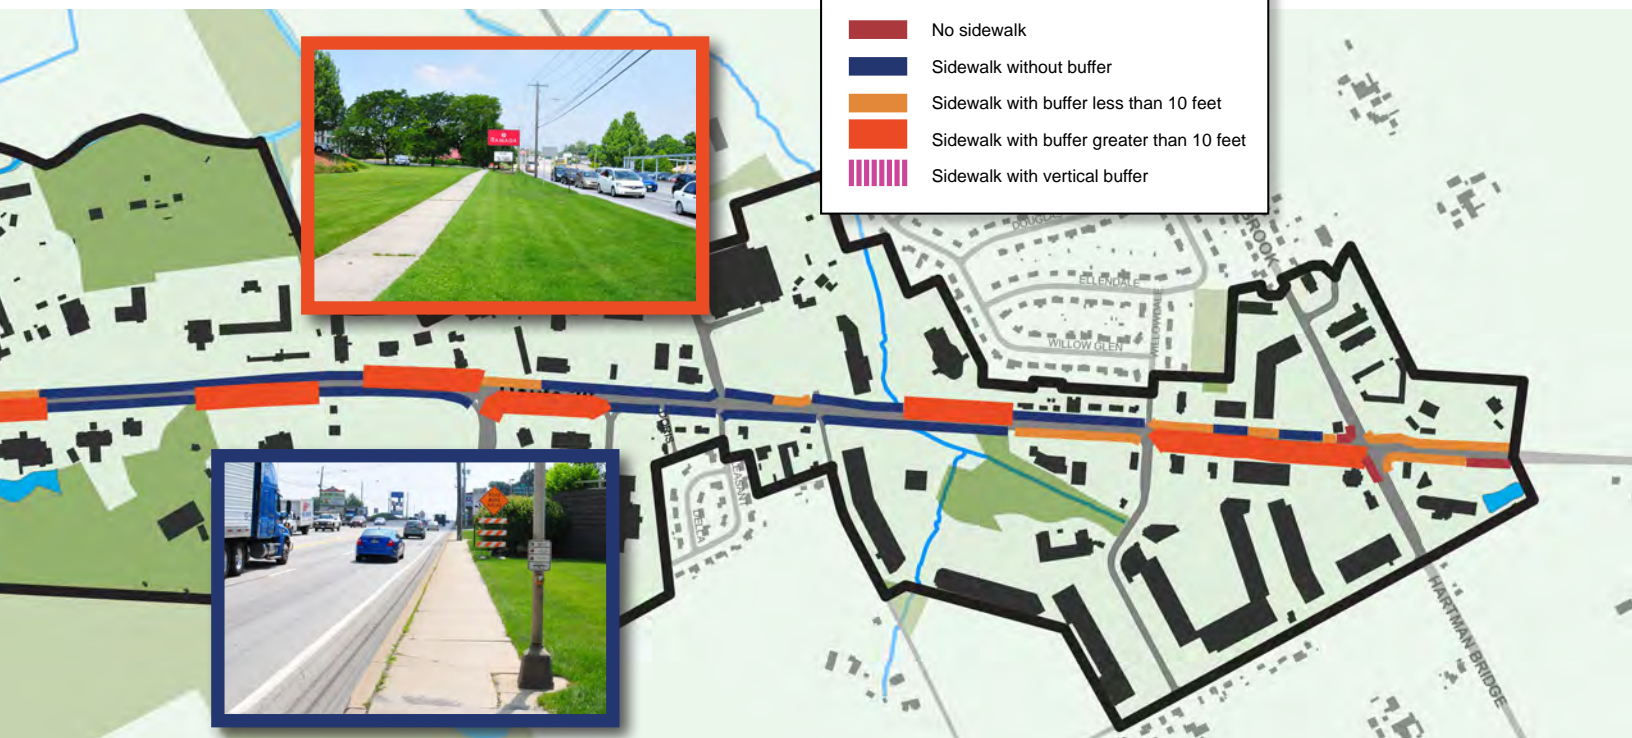
### 5. Sidewalks with a vertical buffer:

- The sidewalk along the Tanger Outlets property includes a metal fence that establishes a visual and physical buffer between car and pedestrian traffic.
- Percentage of corridor frontage: One percent

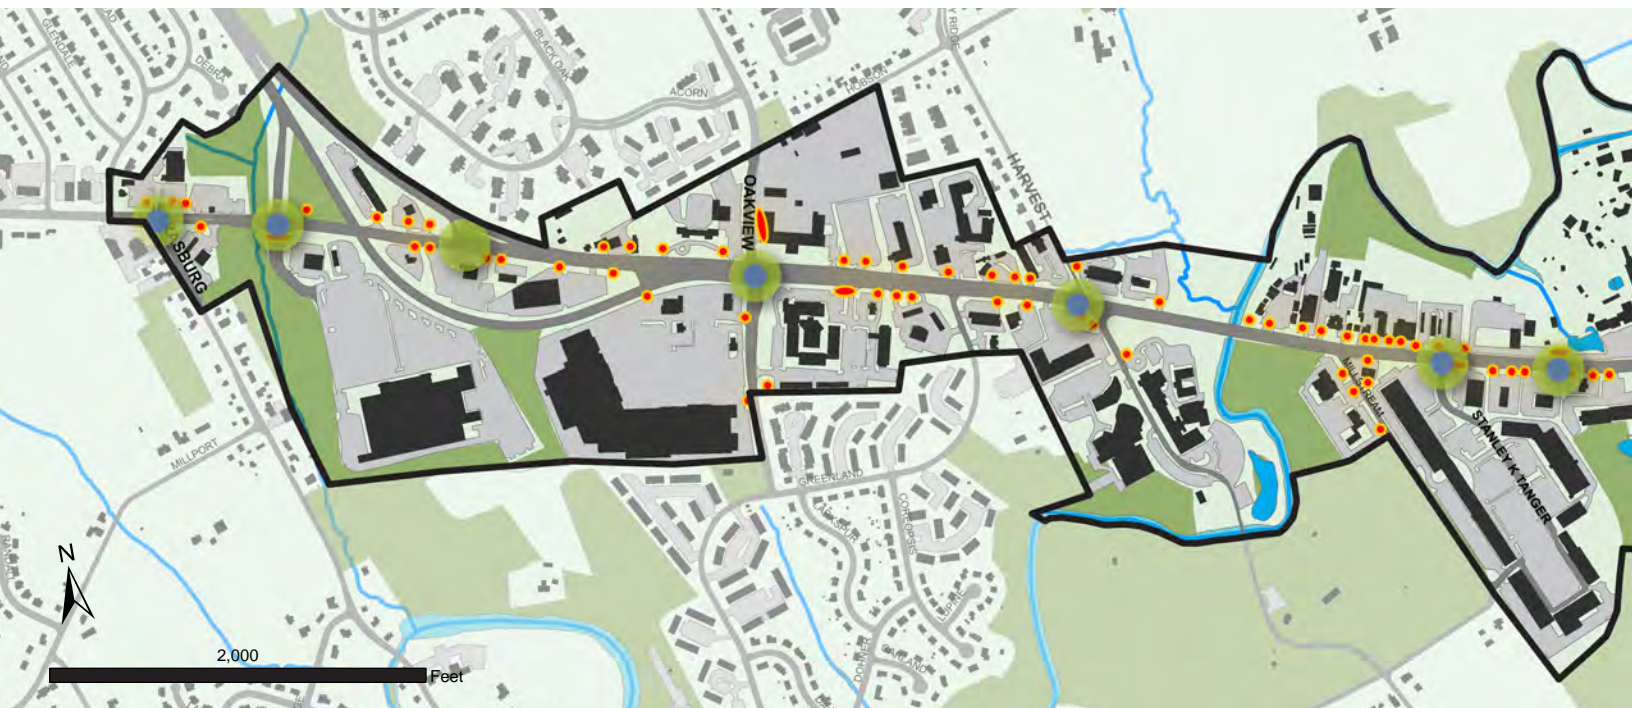
### **curb cuts and intersections**

Pedestrian crosswalks exist at all signalized intersections in the Study Area. With the addition of the signal at the Lancaster Host Hotel, the corridor will contain 13 signalized intersections. The location of each is shown on the map below. The average distance between the intersections is one-quarter mile, providing pedestrians with a maximum of one-eighth of a mile (approximately a three-minute walk) to walk along the corridor to reach the nearest intersection.

While crosswalks exist, the crossing experience is still overwhelming for many pedestrians. In most locations, people must cross five full lanes of pavement in an uninviting environment. Improved crosswalk markings, countdown crossing signals, and where space permits, center median pedestrian refuges and curb bulb-outs to reduce crossing distances, would greatly improve the experience.

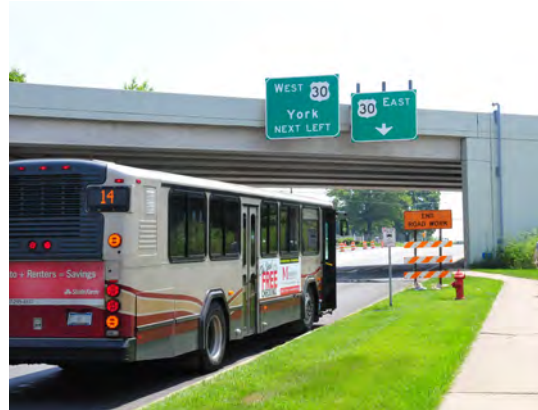
*Bus stop in front of Walmart Shopping Center*

- Transit stop facilities are a low hanging fruit issue for the corridor to address. The current facilities are inadequate and basic improvements such as concrete pads, benches, and sign improvements at each stop would be beneficial.
- Bus stop locations need to be coordinated with improvements to crosswalks and sidewalks.
- Shuttle service could provide targeted service to area visitors; however, shuttles require a lot of attention to design to make them attractive to a non-transit riding audience. Identifying a mechanism to fund or partially subsidize such shuttle service would be crucial to successful implementation in the corridor.

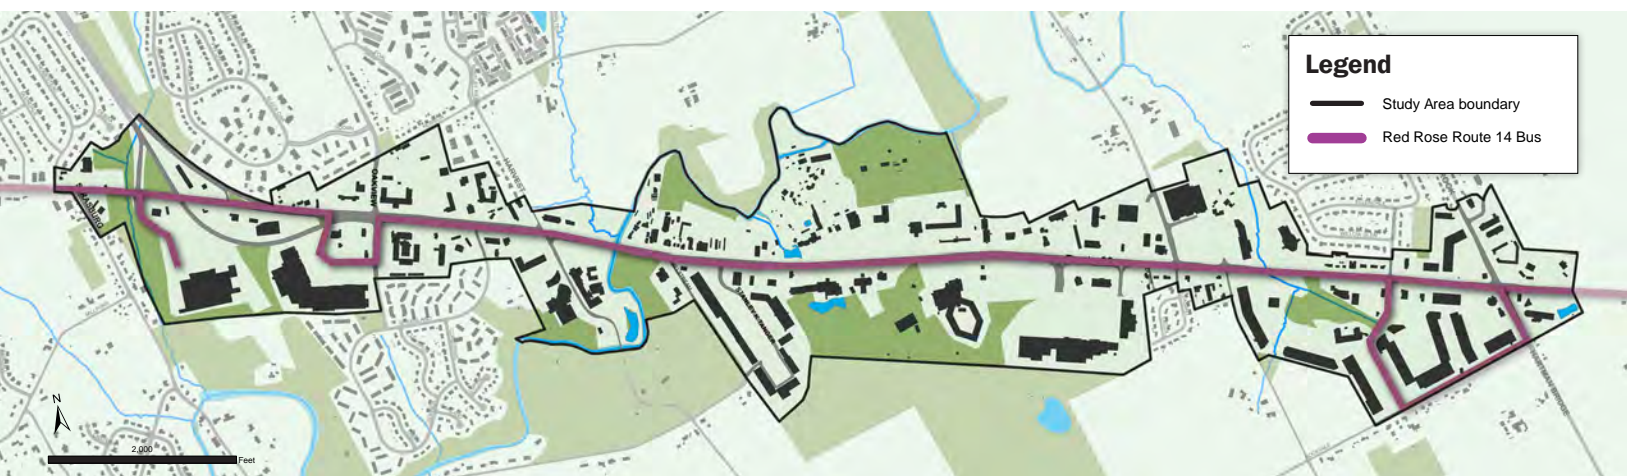
## transit routes

The Study Corridor is served by Red Rose Transit Route 14, which runs from the Queen Street Station Transit Center in downtown Lancaster to the Rockvale Square Outlet Mall. Connections are available to most other Red Rose Transit routes at the Queen Street Station including the Historic Downtown Trolley to the Amtrak station. Schedules are focused to serve retail and service job start and end times and shopping trips.

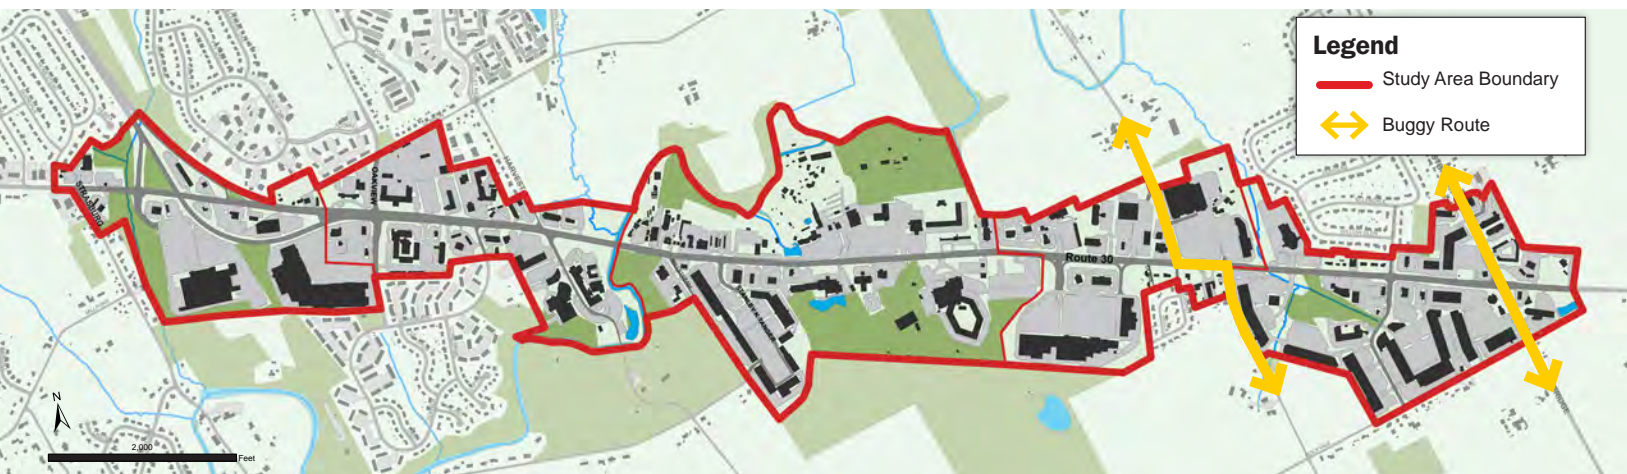
### buggy routes

Field visits indicate that routes include Rockvale Road parallel to Lincoln Highway, Witmer Road then across to Bowman Road, and along Route 896. Of those observed routes only the Witmer Road to Bowman Road route brings buggies onto Lincoln Highway for a short distance. Other observed routes simply cross Lincoln Highway at key locations.

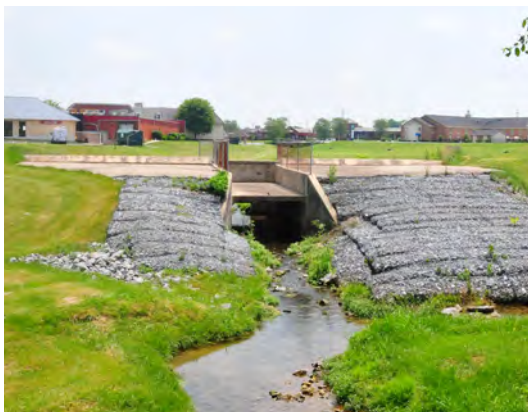
*Stormwater device at Rockvale Outlet*

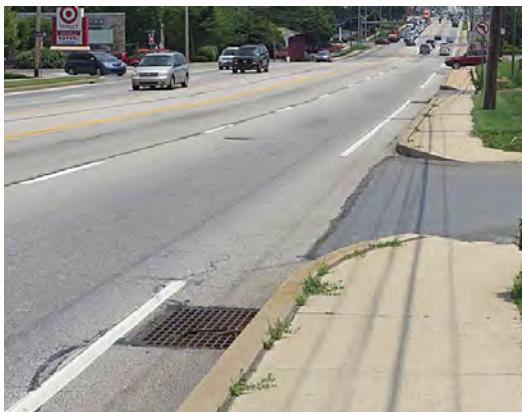
*Stormwater grate at Travelodge entrance*

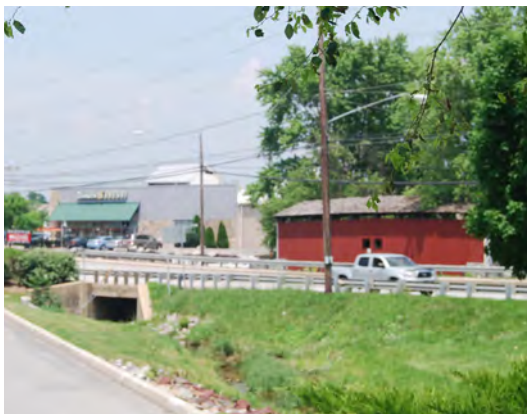
*Drainage area at Rockvale Outlets*

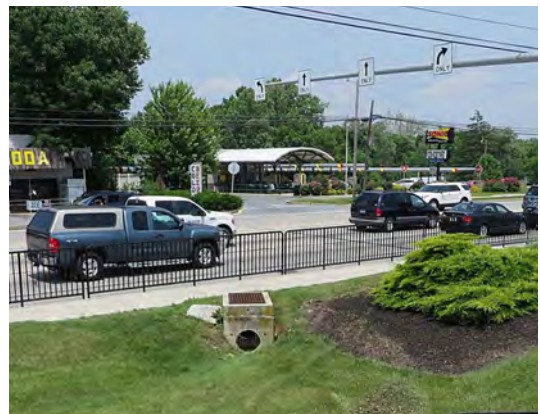
*Landscaped swale at Tanger entrance*

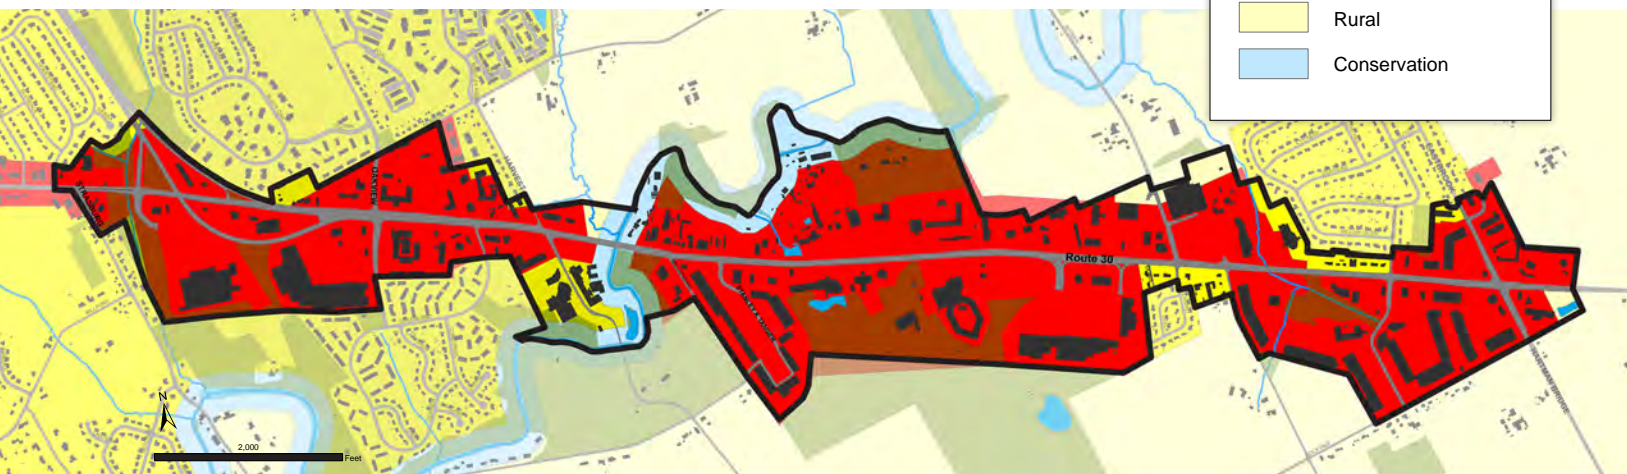
### zoning districts

Four districts directly front the corridor: C-3 Commercial, R-2 Residential, Conservation, and Floodplain. Two additional districts, R-3 Residential and Rural, are located in the Study Area but do not have frontage directly on Lincoln Highway.
